**Stevens Forest to Downtown  
Columbia Road Shared Use Path  
Basis of Design Report  
Broken Land Parkway to Little Patuxent Parkway**

October 2016

Prepared for the Howard County Bureau of Engineering  
& Howard County Office of Transportation

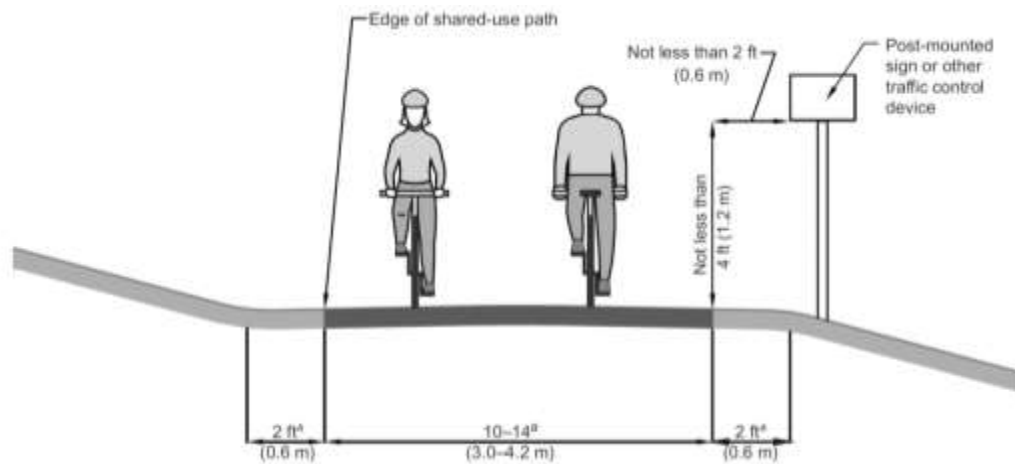
**Figure 1: Typical Cross Section of Two-Way, Shared Use Path on Independent Right-of-Way (Figure 5-2, AASHTO Guide for the Development of Bicycle Facilities, 2012)**

As depicted in Figure 1, the minimum width of a shared use path accommodating traffic in two directions is 10-feet with 2-foot shoulders on each side. In cases of obstructions or low bicycle and pedestrian volumes, an eight foot minimum width can be utilized. Per the SHA Bike Guide, trails less than 10-feet wide will require a design waiver. Wider trails (11' to 14' wide) are recommended for locations that are anticipated to serve a high percentage of pedestrians and a high user volume (i.e. more than 300 users in the peak hour.) Per AASHTO, a minimum of 2-feet of separation is required between the edge of the shared use path and post-mounted signs, landscape plantings, bridge abutments, or other adjacent obstacles; however, the SHA Bike Guide requires a minimum of 3-feet of separation from these features. Additionally, if a shared-use path is installed parallel to a street, consideration should be made to increasing the buffer width to 5-feet between the road and shared-use path.

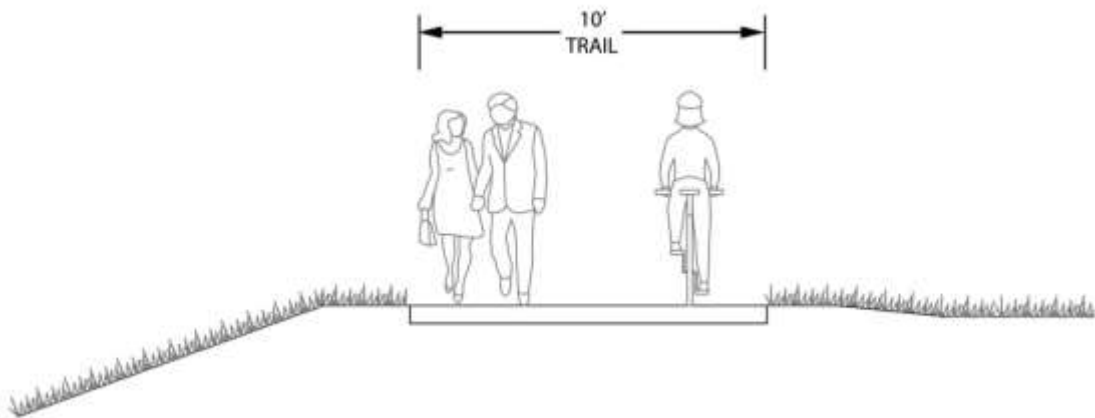
Figure 3: Typical Shared Use Path Cross Section

Consistent with the AASHTO Guide for the Development of Bicycle Facilities, a minimum width of 10-feet is recommended for the path width. A minimum of 2-feet of separation is recommended between signs, retaining walls, and shallow swales; a 1-foot to 2-foot separation is recommended between boardwalk or other railings and the path where possible. Three typical cross-sections for the path are provided below as Figures 3 through 5. Figure 4 could be used in the underpass areas based on coordination with SHA regarding acceptable designs within their right-of-way.

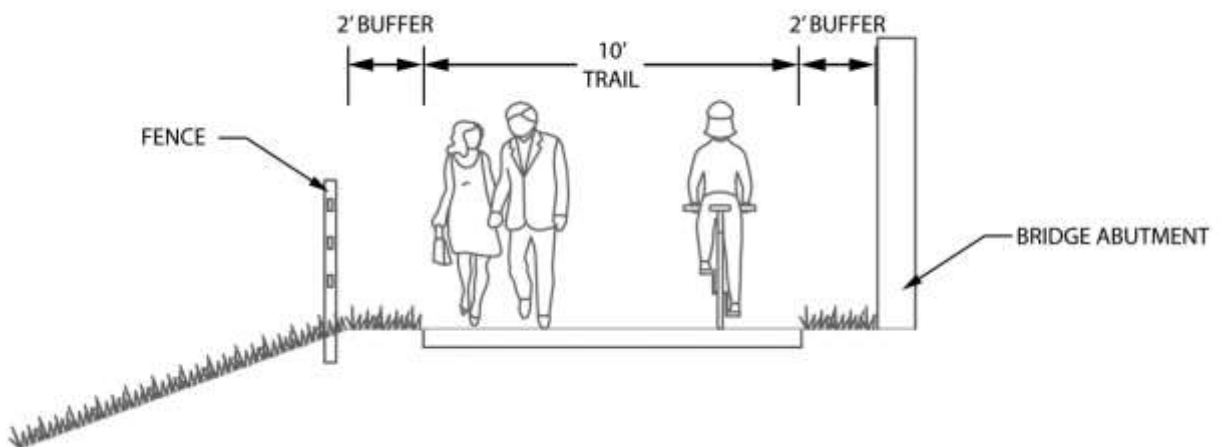
Figure 4: Typical Cross Section showing At-Grade Condition Below Underpass

The proposed alignment will route the path under three bridges: the two Route 29 bridges and the Broken Land Parkway bridge over Little Patuxent River. A minimum vertical clearance of 10-feet is desirable for adequate vertical shy distances per AASHTO. The SHA Bike Guide indicates a minimum clearance of 8 feet below tree branches, 10 feet recommended, but does not provide a vertical

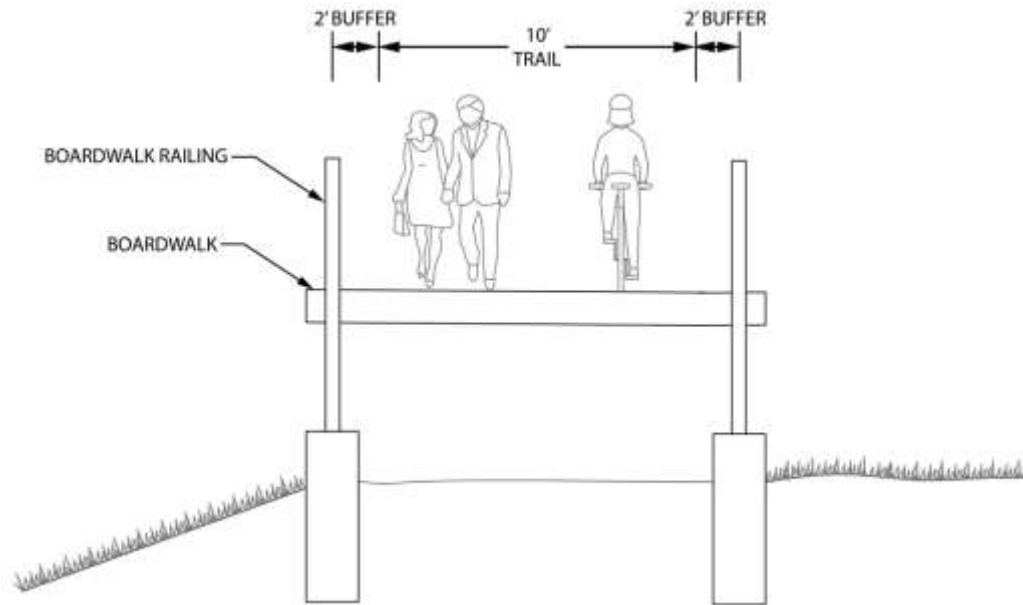
**Figure 5: Typical Cross Section showing Boardwalk Design**

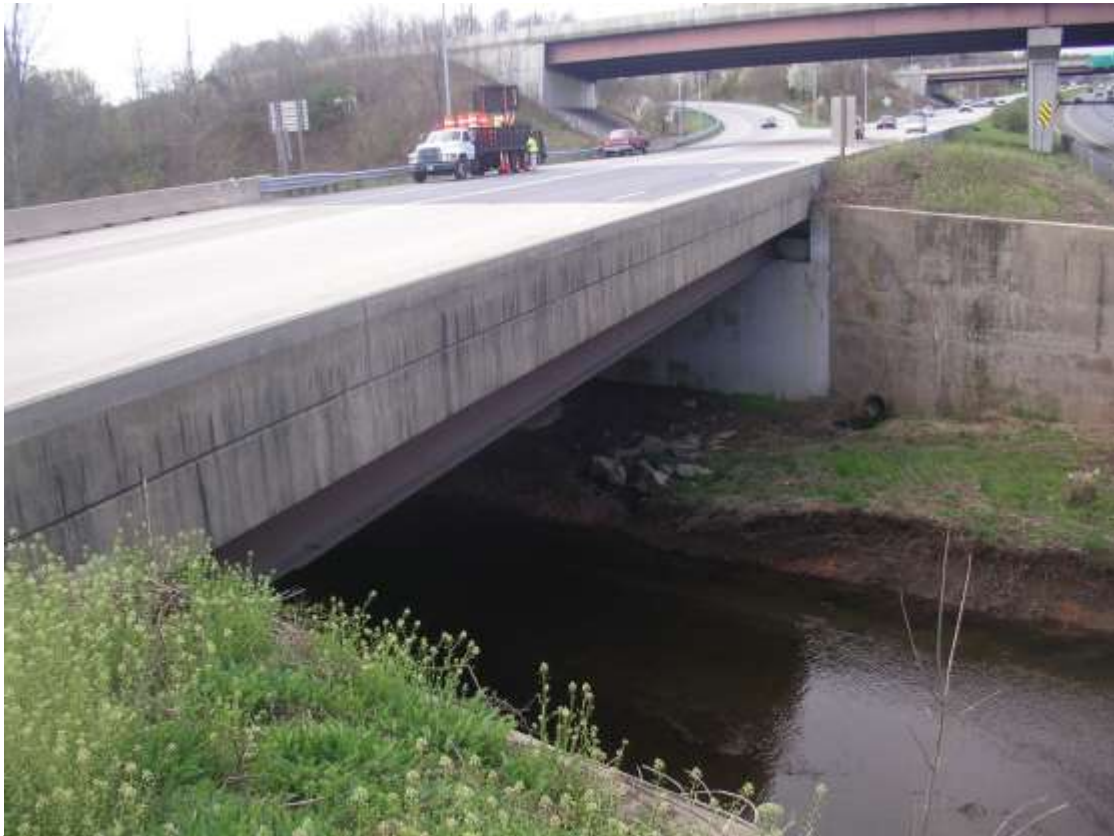
Photo 1: Northbound Columbia Pike Bridge over Little Patuxent River looking South

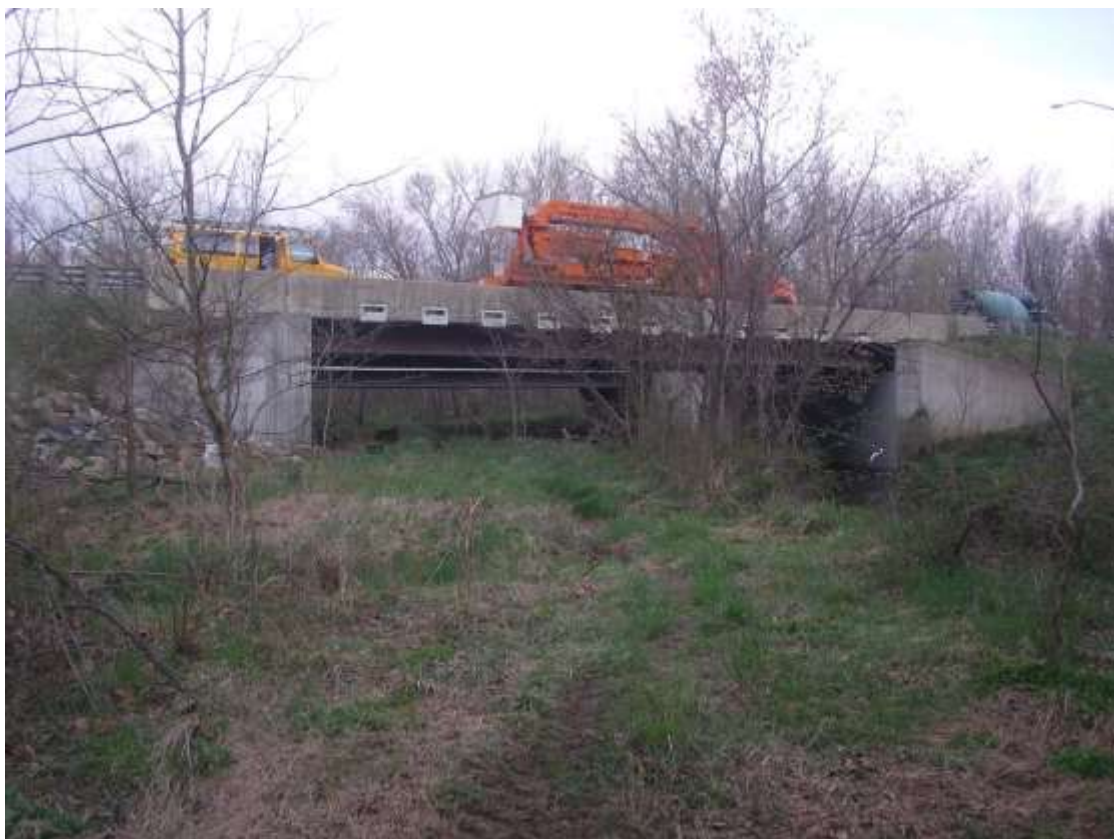
Photo 2: East of Columbia Pike (Rt 29) Bridge looking West

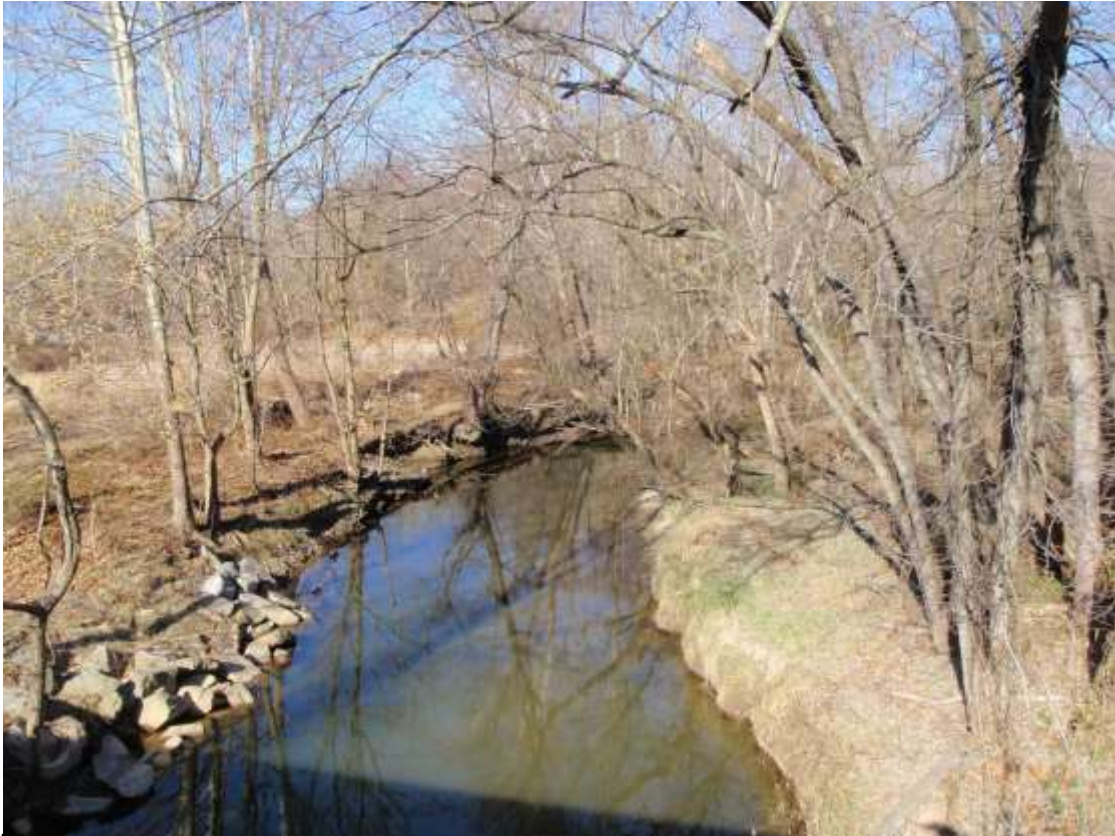
Photo 3: Little Patuxent River looking west from Columbia Pike (Rt 29)

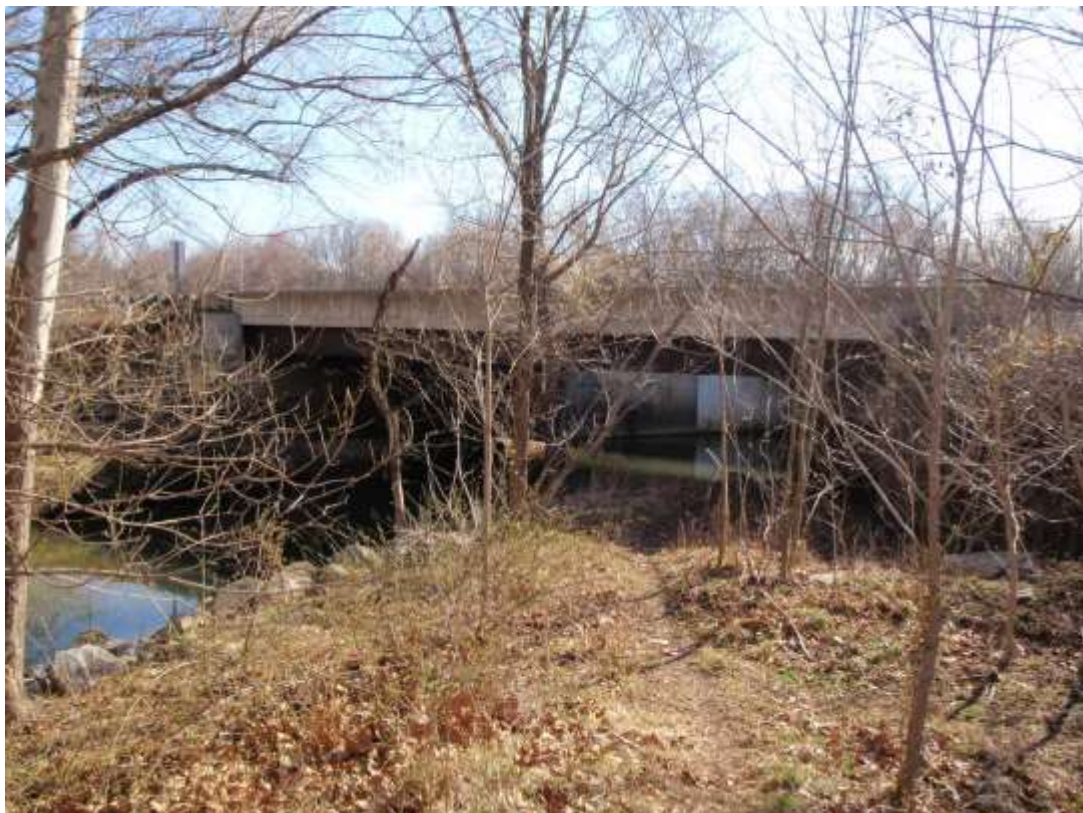
Photo 4: Looking east toward Columbia Pike (Rt 29) Bridge

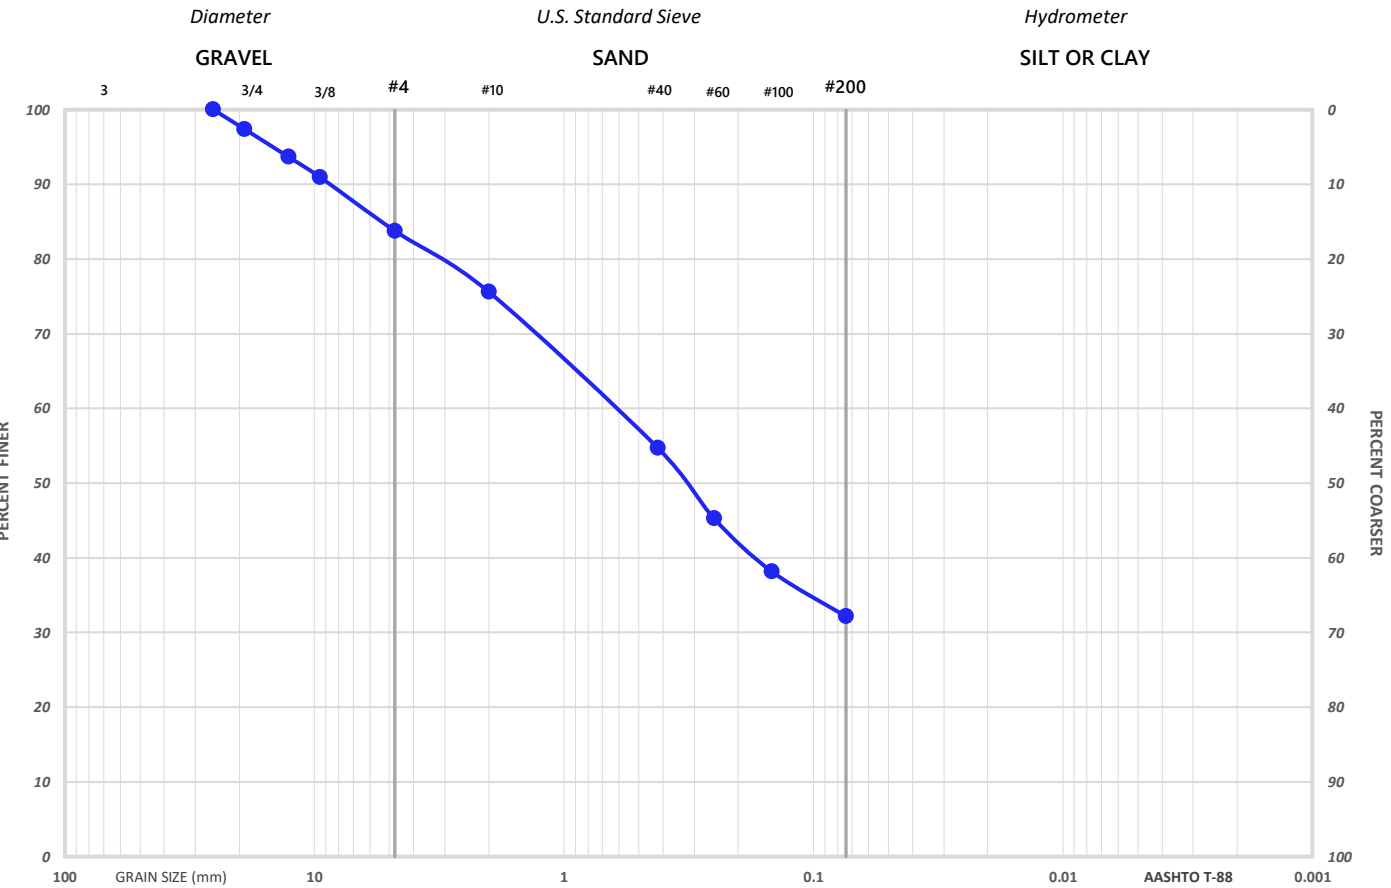
GRAIN SIZE ANALYSIS

Diameter	75.0	50.8	37.5	25.4	19.0	12.7	9.51	4.75	2.0	0.42	0.25	0.147	0.074
Sieve Size	3"	2"	1.5"	1"	3/4"	1/2"	3/8"	#4	#10	#40	#60	#100	# 200
% Passing	-	-	-	100.0	97.4	93.7	91.0	83.8	75.6	54.7	45.3	38.2	32.2

Dark green silty SAND with gravel and rock

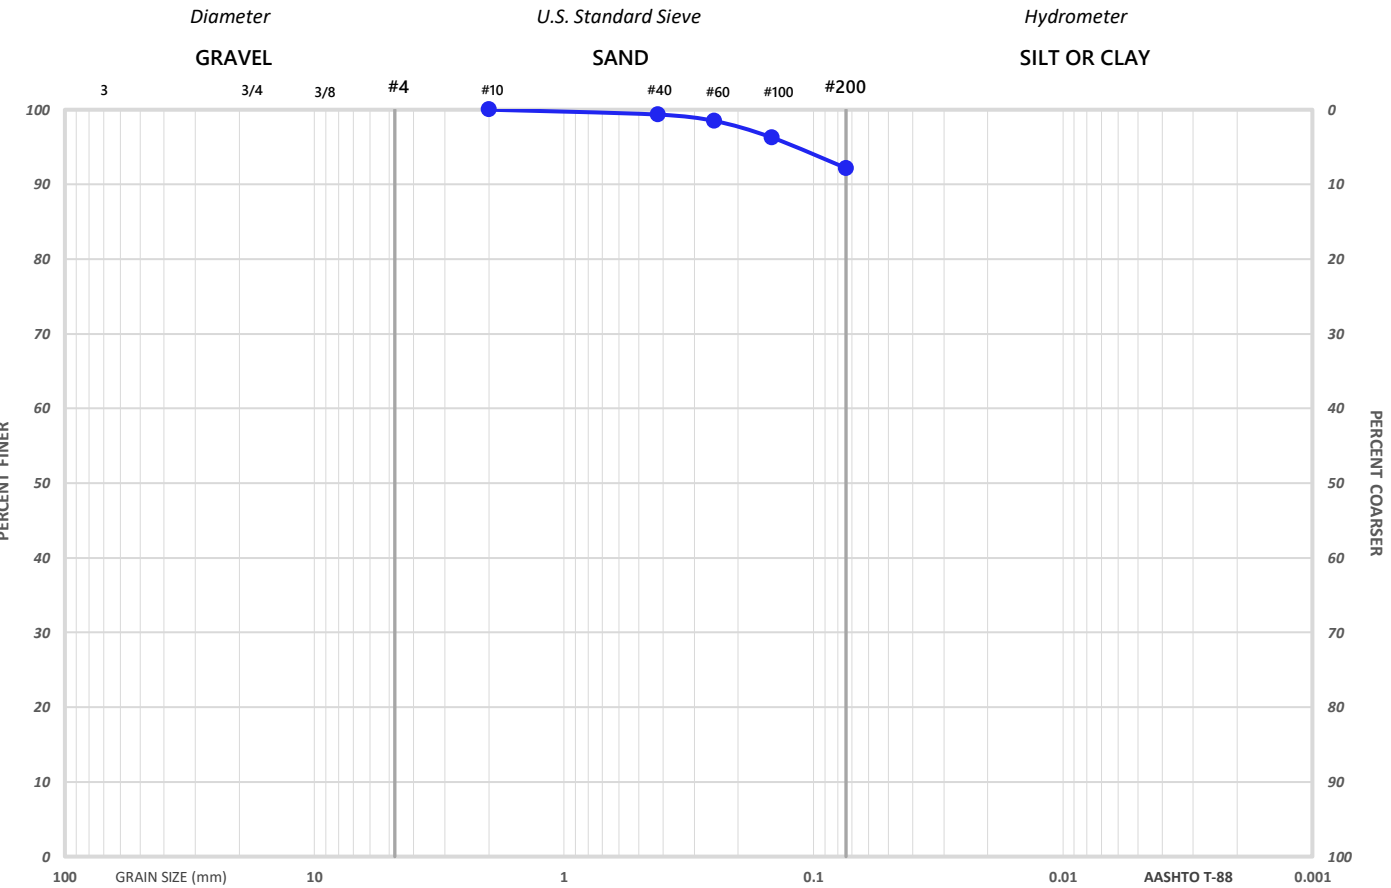
GRAIN SIZE ANALYSIS

Diameter	75.0	50.8	37.5	25.4	19.0	12.7	9.51	4.75	2.0	0.42	0.25	0.147	0.074
Sieve Size	3"	2"	1.5"	1"	3/4"	1/2"	3/8"	#4	#10	#40	#60	#100	# 200
% Passing	-	-	-	-	-	-	-	-	100.0	99.3	98.5	96.3	92.2

ATTERBERG LIMITS		CLASSIFICATION	
Liquid Limit	41	AASHTO	A-7-6
Plastic Limit	26	USCS	ML
Plasticity Index	15

SOIL DESCRIPTION
Dark green SILT

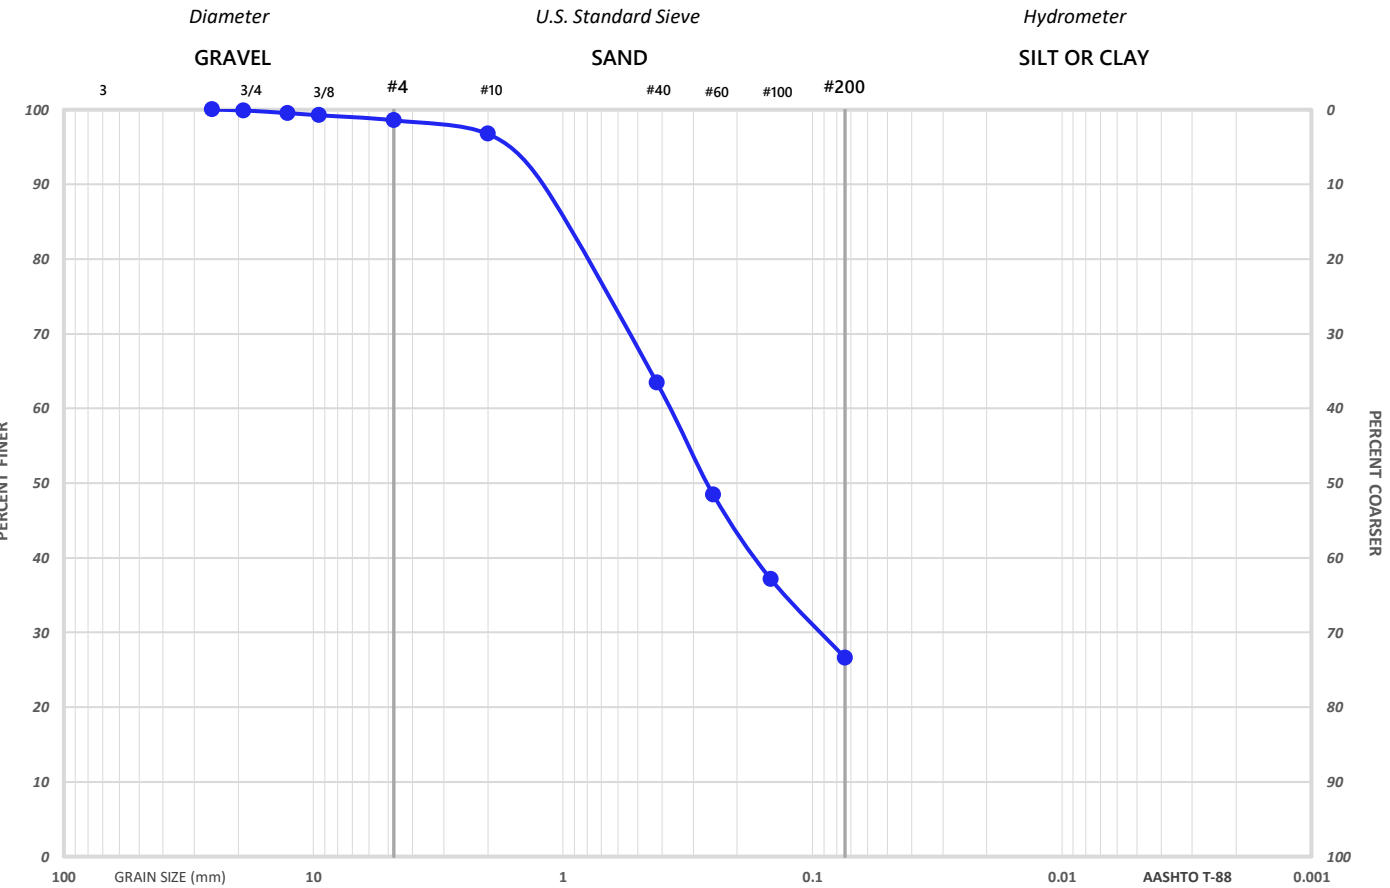
GRAIN SIZE ANALYSIS

Diameter	75.0	50.8	37.5	25.4	19.0	12.7	9.51	4.75	2.0	0.42	0.25	0.147	0.074
Sieve Size	3"	2"	1.5"	1"	3/4"	1/2"	3/8"	#4	#10	#40	#60	#100	# 200
% Passing	-	-	-	100.0	99.9	99.5	99.3	98.6	96.8	63.4	48.5	37.2	26.6

ATTERBERG LIMITS		CLASSIFICATION	
Liquid Limit	28	AASHTO	A-2-4
Plastic Limit	NP	USCS	SM
Plasticity Index	NP

SOIL DESCRIPTION
Brown silty SAND

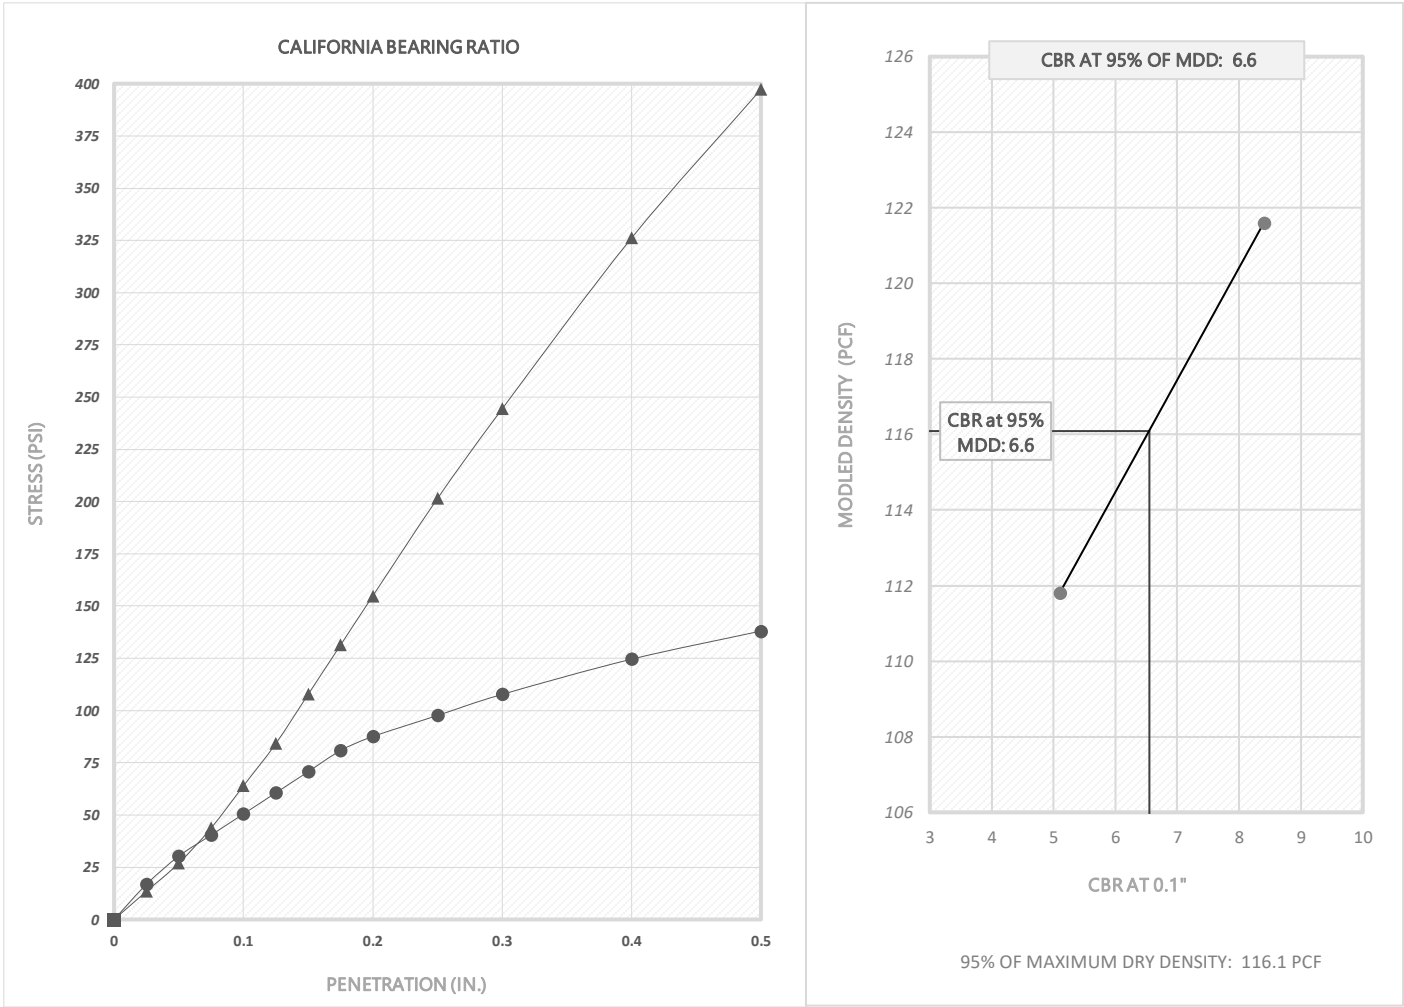
CALIFORNIA BEARING RATIO TEST RESULTS

AS MOLDED			AFTER SOAK						
	Compaction	Density	Moisture	Compaction	Density	Moisture	CBR at 0.1"	CBR at 0.2"	Blows	Swell
●	91.5	111.8	11.0	91.0	111.2	15.2	5.1	5.8	15	0.66
▲	99.5	121.6	11.4	99.4	121.4	12.0	8.4*	11.9*	56	0.55
■	-	-	-	-	-	-	-	-	-	-
	%	PCF	%	%	PCF	%	* DENOTES CORRECTED VALUE		#	%
MAXIMUM DRY DENSITY		OPTIMUM MOISTURE CONTENT		COMPACTION METHOD		CBR METHOD		SURCHARGE		
122.2 PCF		11.2 %		AASHTO T-99 (C)		AASHTO T-193		75 PSF

MC	LL	PL	PI	USCS	AASHTO	FINES	SOIL DESCRIPTION
-	31	23	8	SM	A-2-4	32.2	Dark green silty SAND with gravel and rock

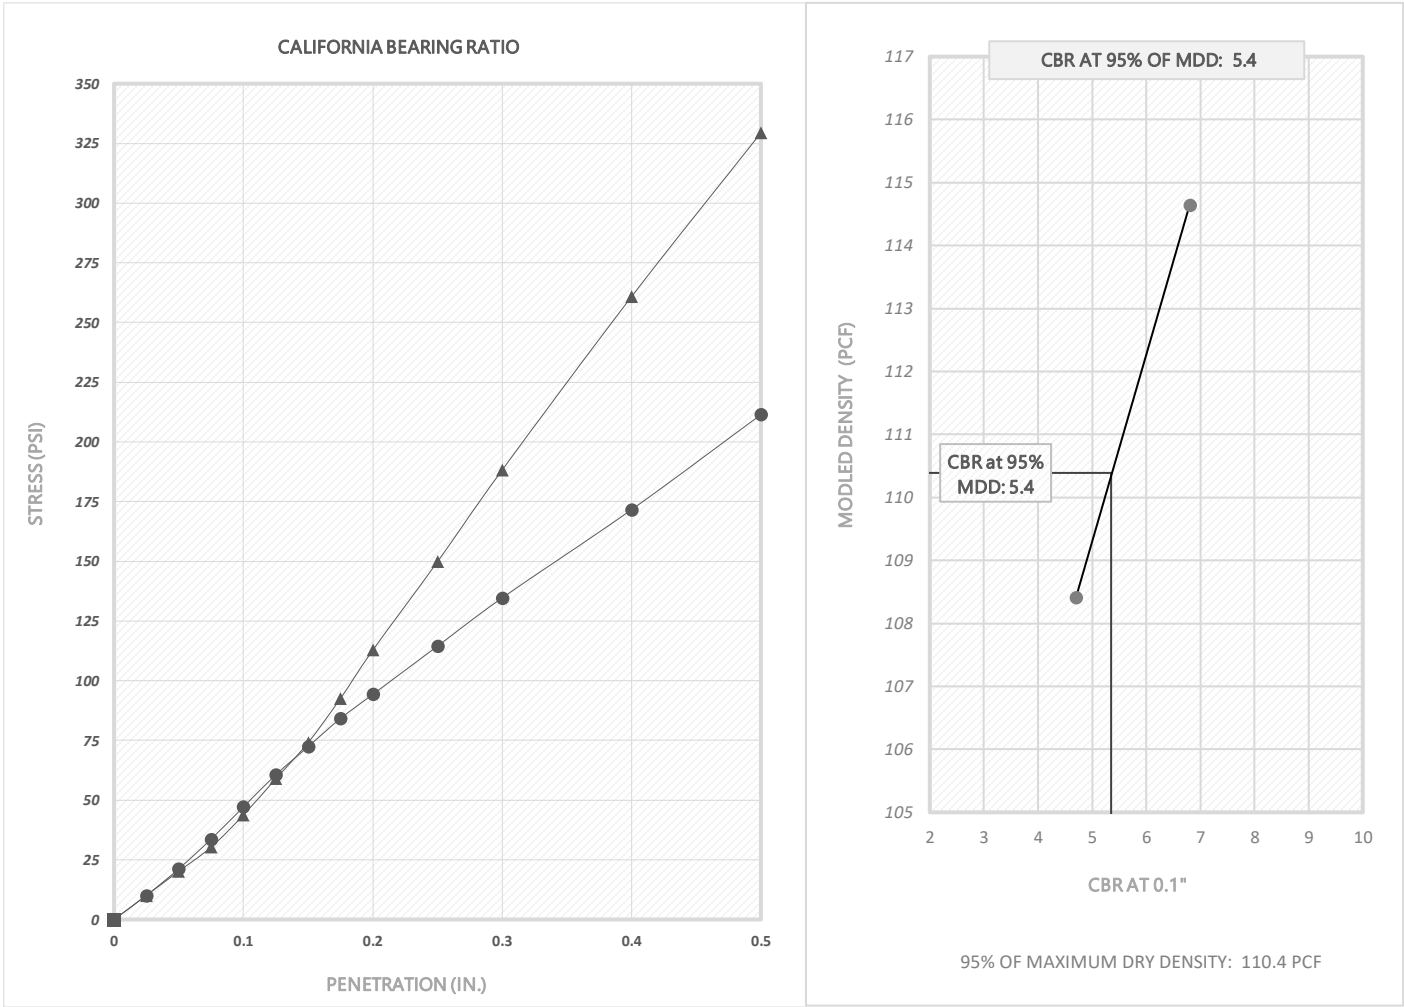
CALIFORNIA BEARING RATIO TEST RESULTS

AS MOLDED			AFTER SOAK						
	Compaction	Density	Moisture	Compaction	Density	Moisture	CBR at 0.1"	CBR at 0.2"	Blows	Swell
●	93.3	108.4	13.7	93.6	108.8	16.2	4.7	6.3	15	0.17
▲	98.7	114.6	13.8	99.3	115.4	14.1	6.8*	9.5*	56	-0.02
■	-	-	-	-	-	-	-	-	-	-
	%	PCF	%	%	PCF	%	* DENOTES CORRECTED VALUE		#	%
MAXIMUM DRY DENSITY		OPTIMUM MOISTURE CONTENT		COMPACTION METHOD		CBR METHOD		SURCHARGE		
116.2 PCF		13.8 %		AASHTO T-99 (C)		AASHTO T-193		75 PSF

MC	LL	PL	PI	USCS	AASHTO	FINES	SOIL DESCRIPTION
-	28	NP	NP	SM	A-2-4	26.6	Brown silty SAND

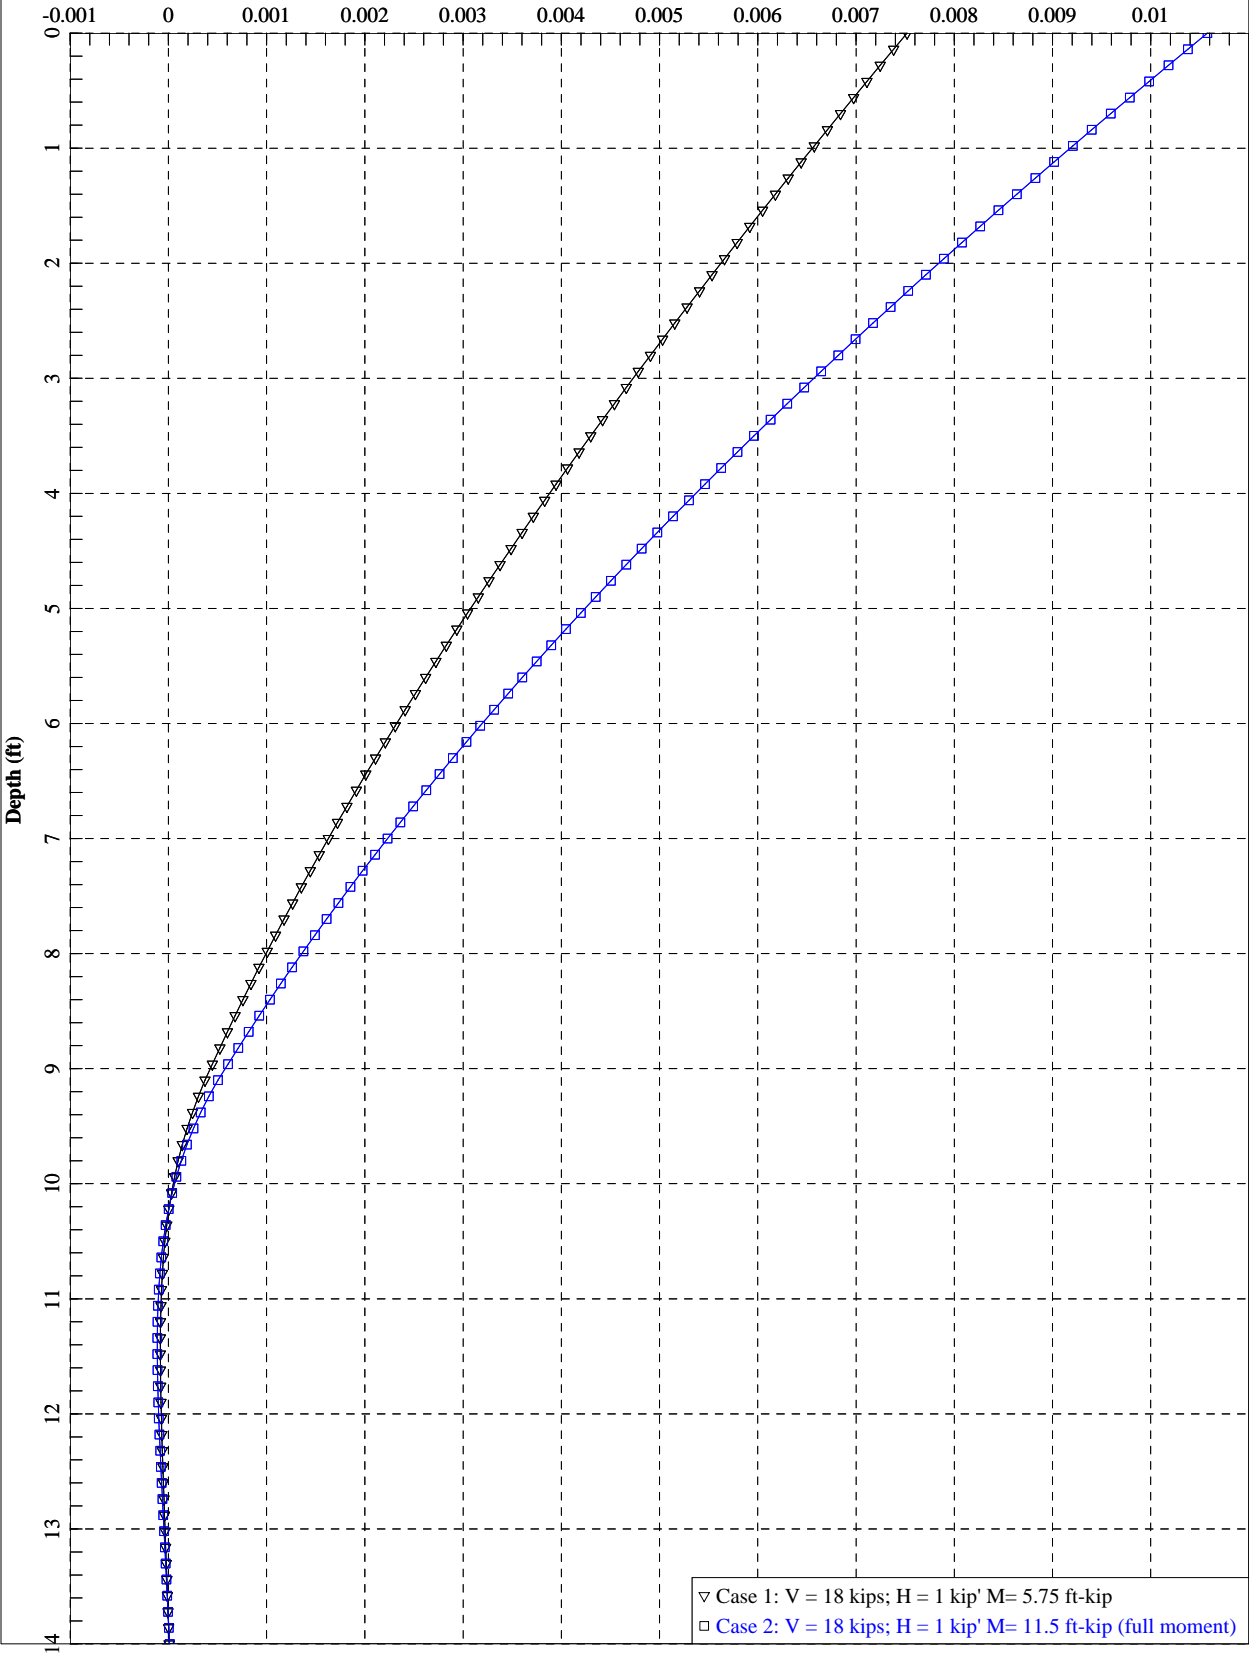
Bridge @ Culvert Drilled Shaft Foundations: 3-ft Dia shaft & 2-ft Dia Rock Socket (@ 4-ft deep)  
Lateral Pile Deflection (inches)

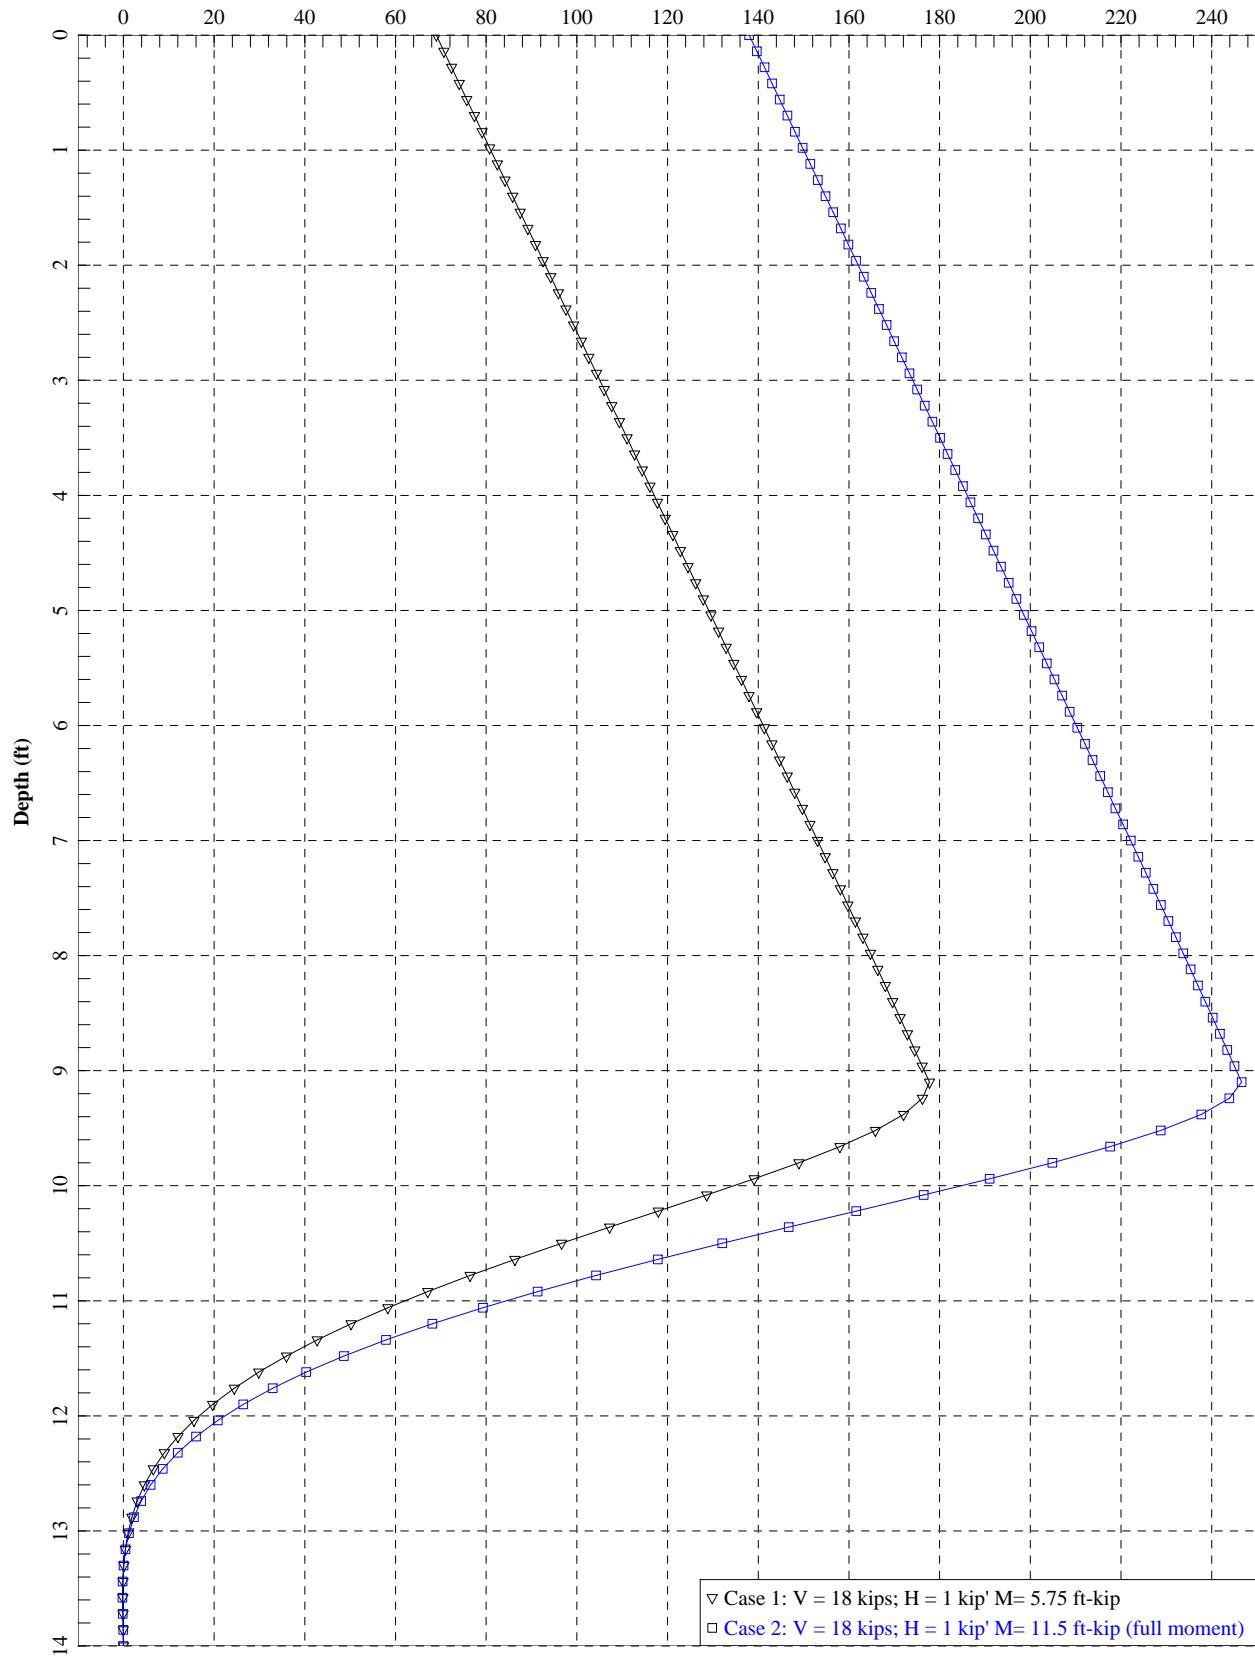
**Bridge @ Culvert Drilled Shaft Foundations: 3-ft Dia shaft & 2-ft Dia Rock Socket (@ 4-ft deep)**  
**Bending Moment (in-kips)**

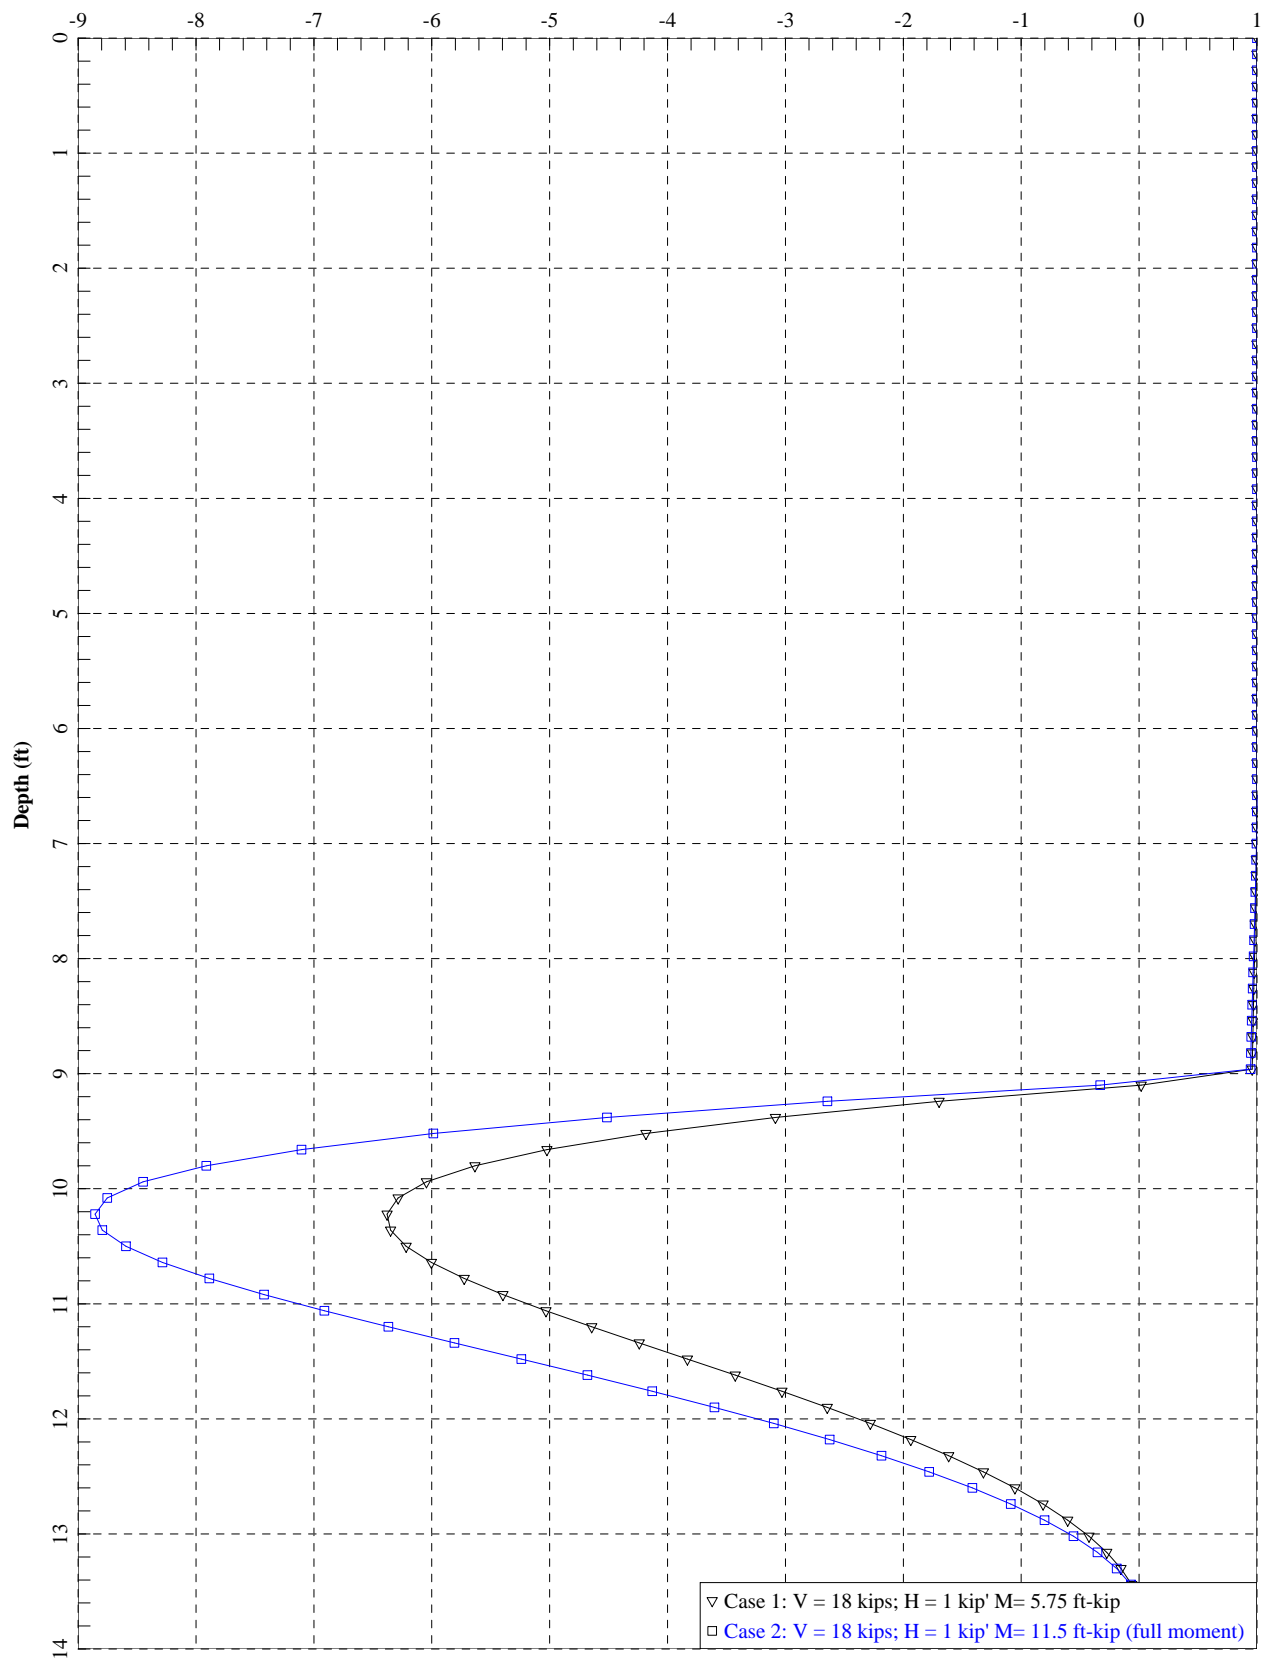
Bridge @ Culvert Drilled Shaft Foundations: 3-ft Dia shaft & 2-ft Dia Rock Socket (@ 4-ft deep)  
Shear Force (kips)

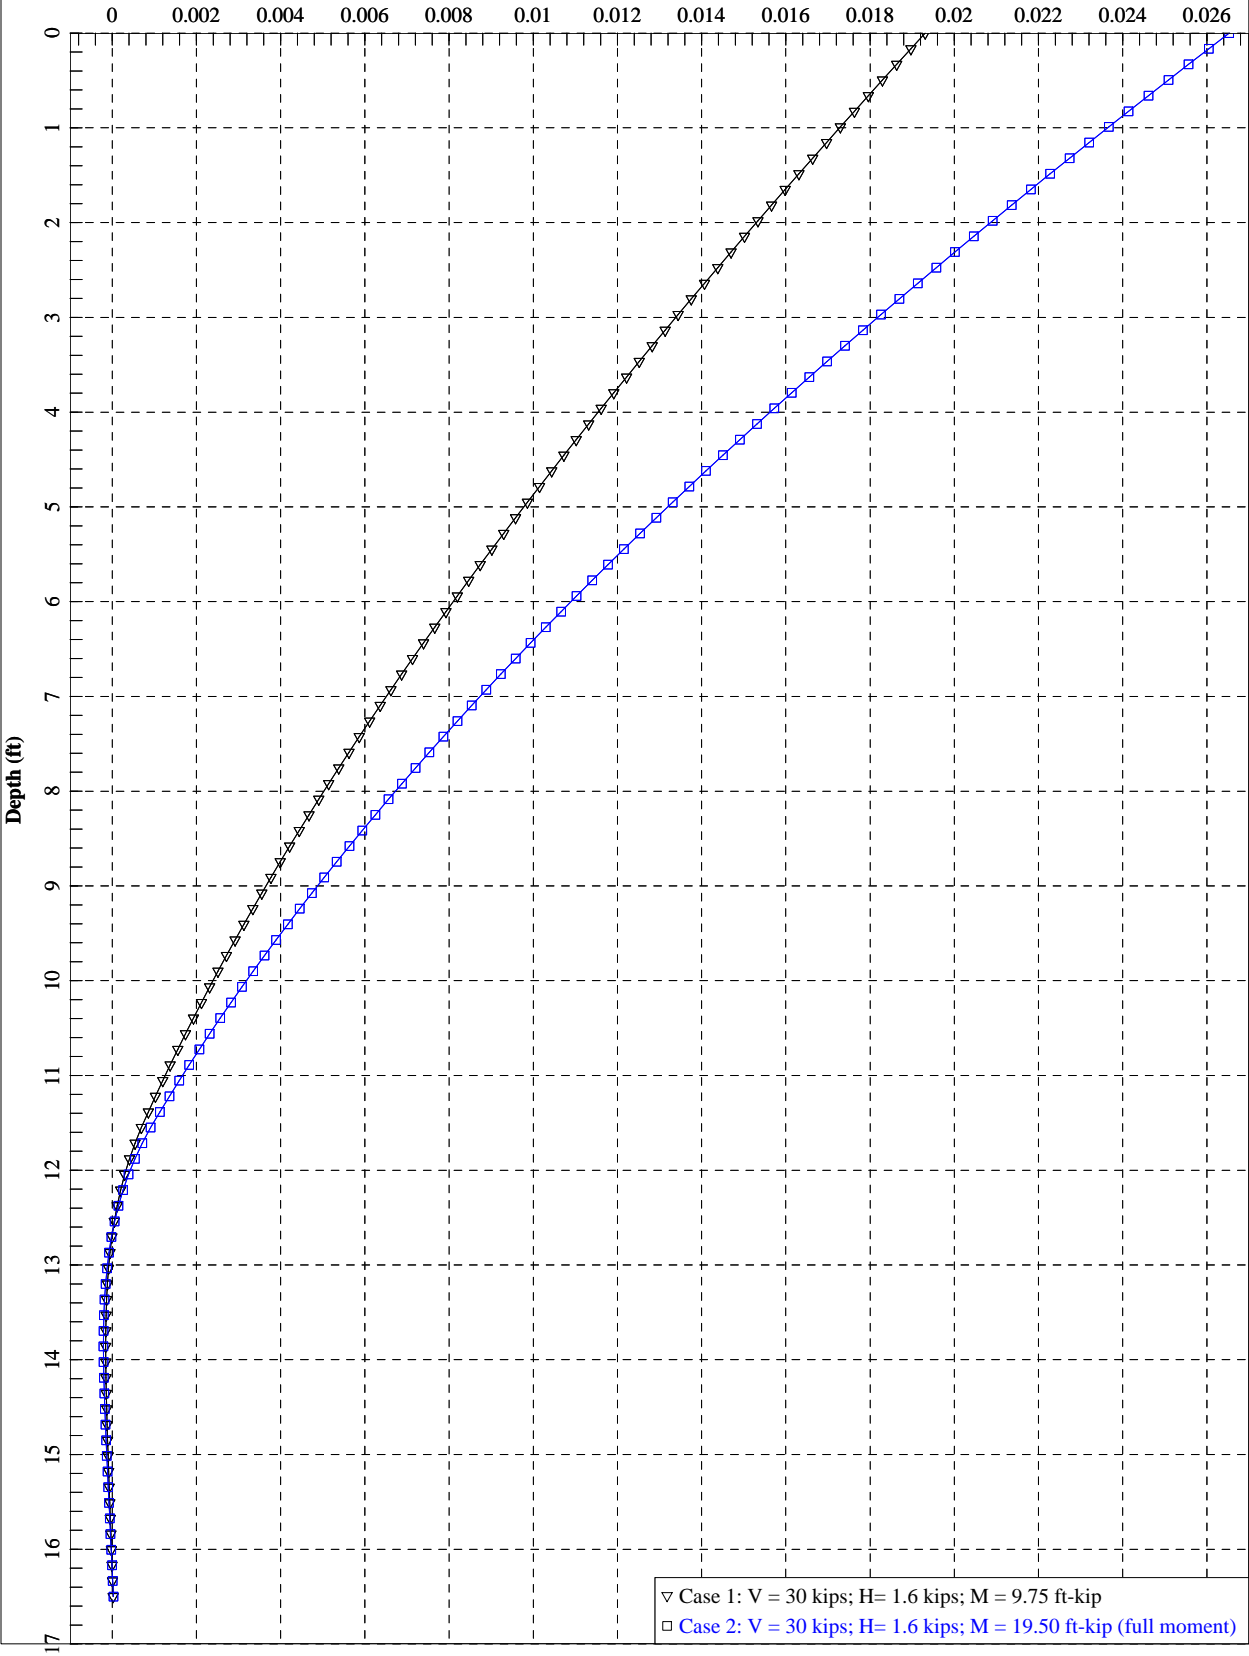
Bridge @ Stream Drilled Shaft Foundations: 3-ft Dia shaft & 2-ft Dia Rock Socket (@ 4-ft deep)  
Lateral Pile Deflection (inches)
