**Stevens Forest to Downtown  
Columbia Road Shared Use Path  
Basis of Design Report  
Broken Land Parkway to Little Patuxent Parkway**

October 2016

Prepared for the Howard County Bureau of Engineering  
& Howard County Office of Transportation

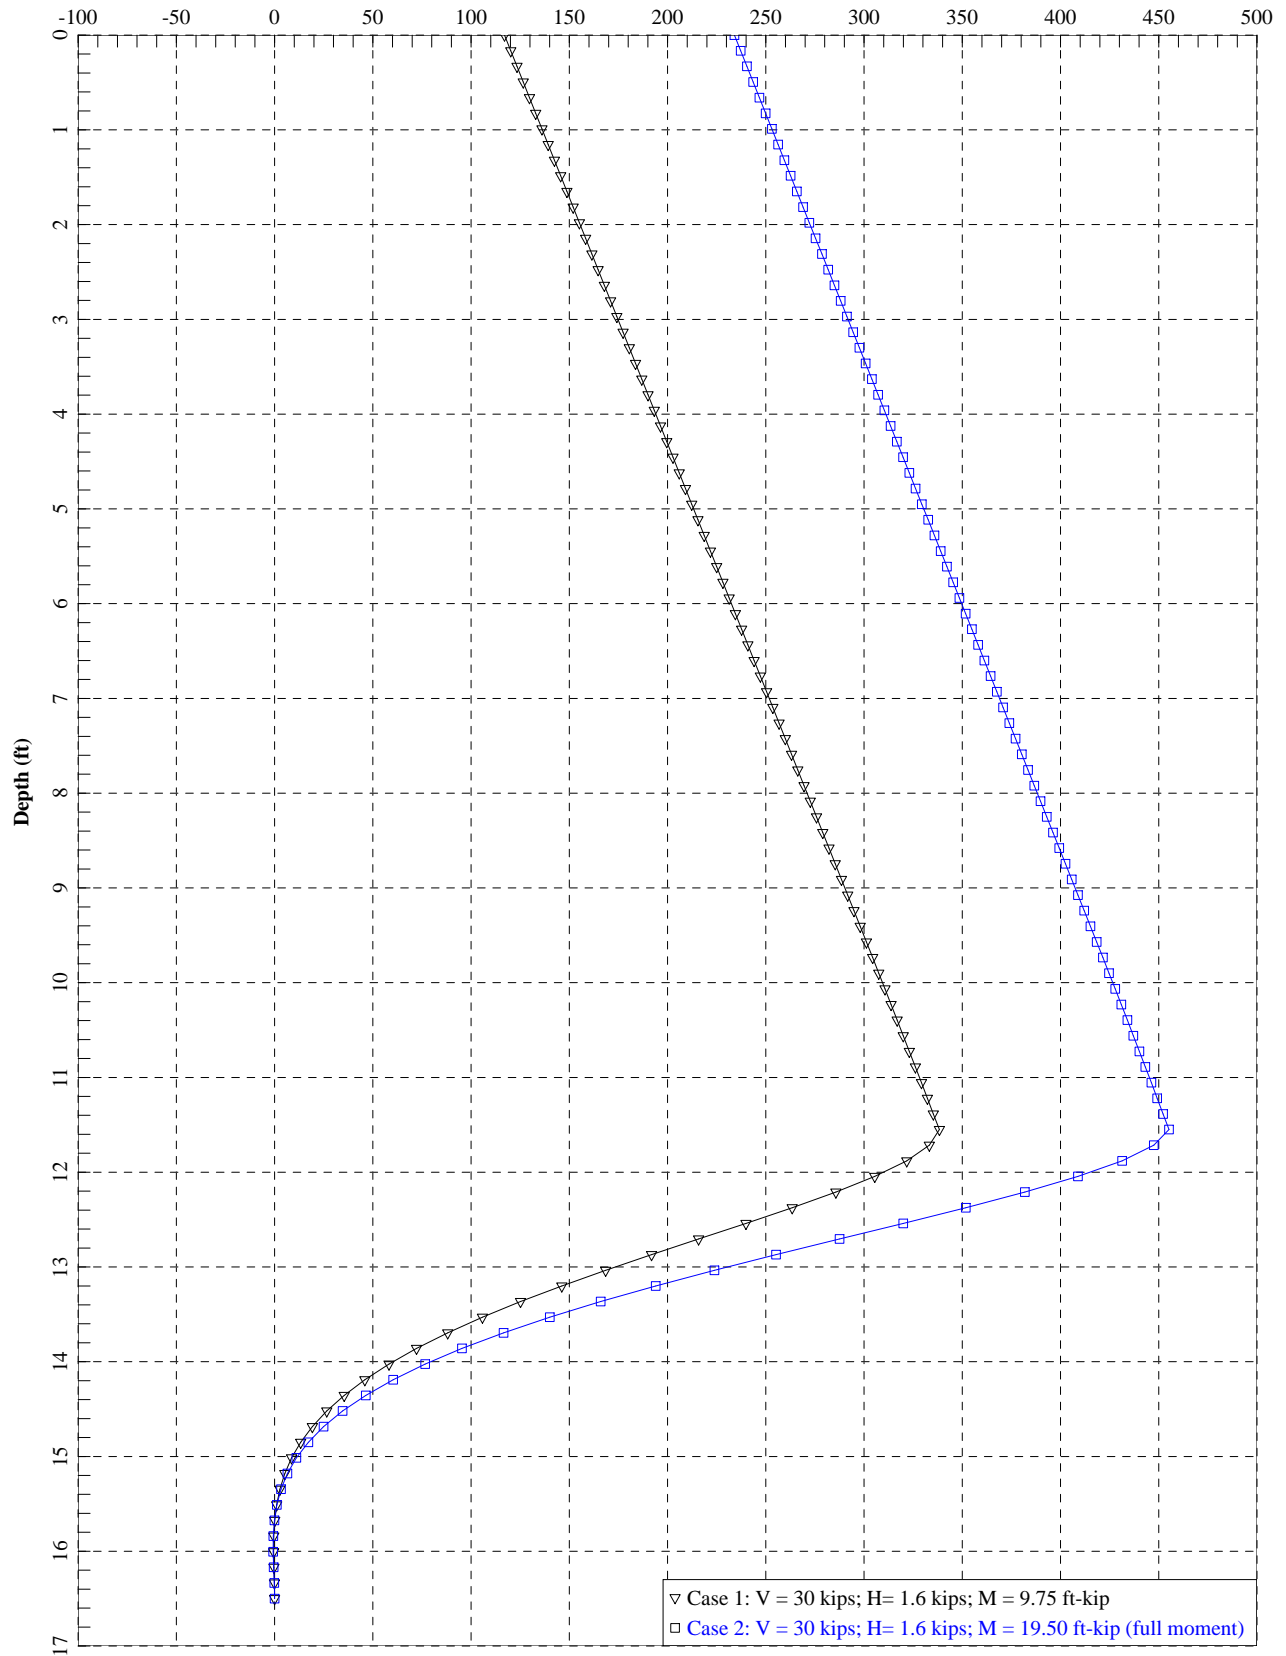
Bridge @ Stream Drilled Shaft Foundations: 3-ft Dia shaft & 2-ft Dia Rock Socket (@ 4-ft deep)  
Bending Moment (in-kips)

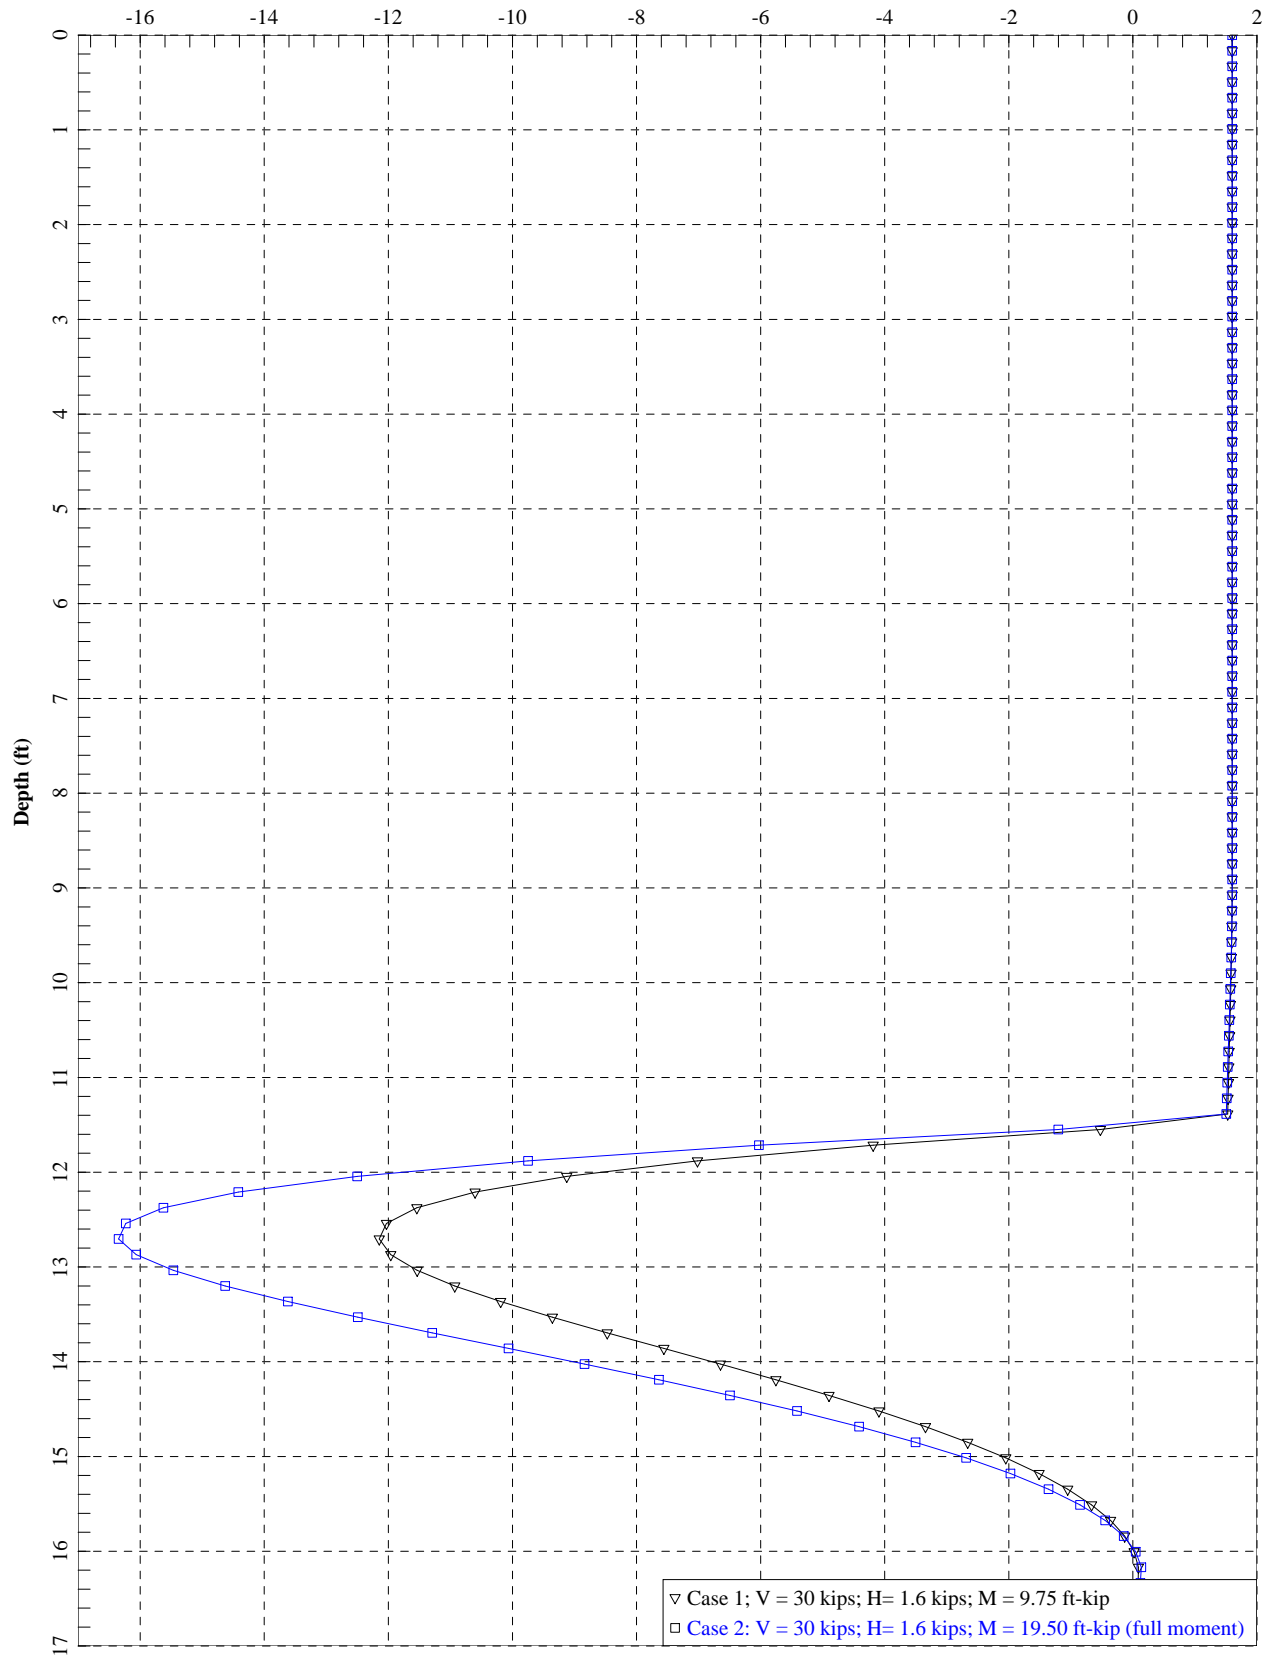
Bridge @ Stream Drilled Shaft Foundations: 3-ft Dia shaft & 2-ft Dia Rock Socket (@ 4-ft deep)  
Shear Force (kips)

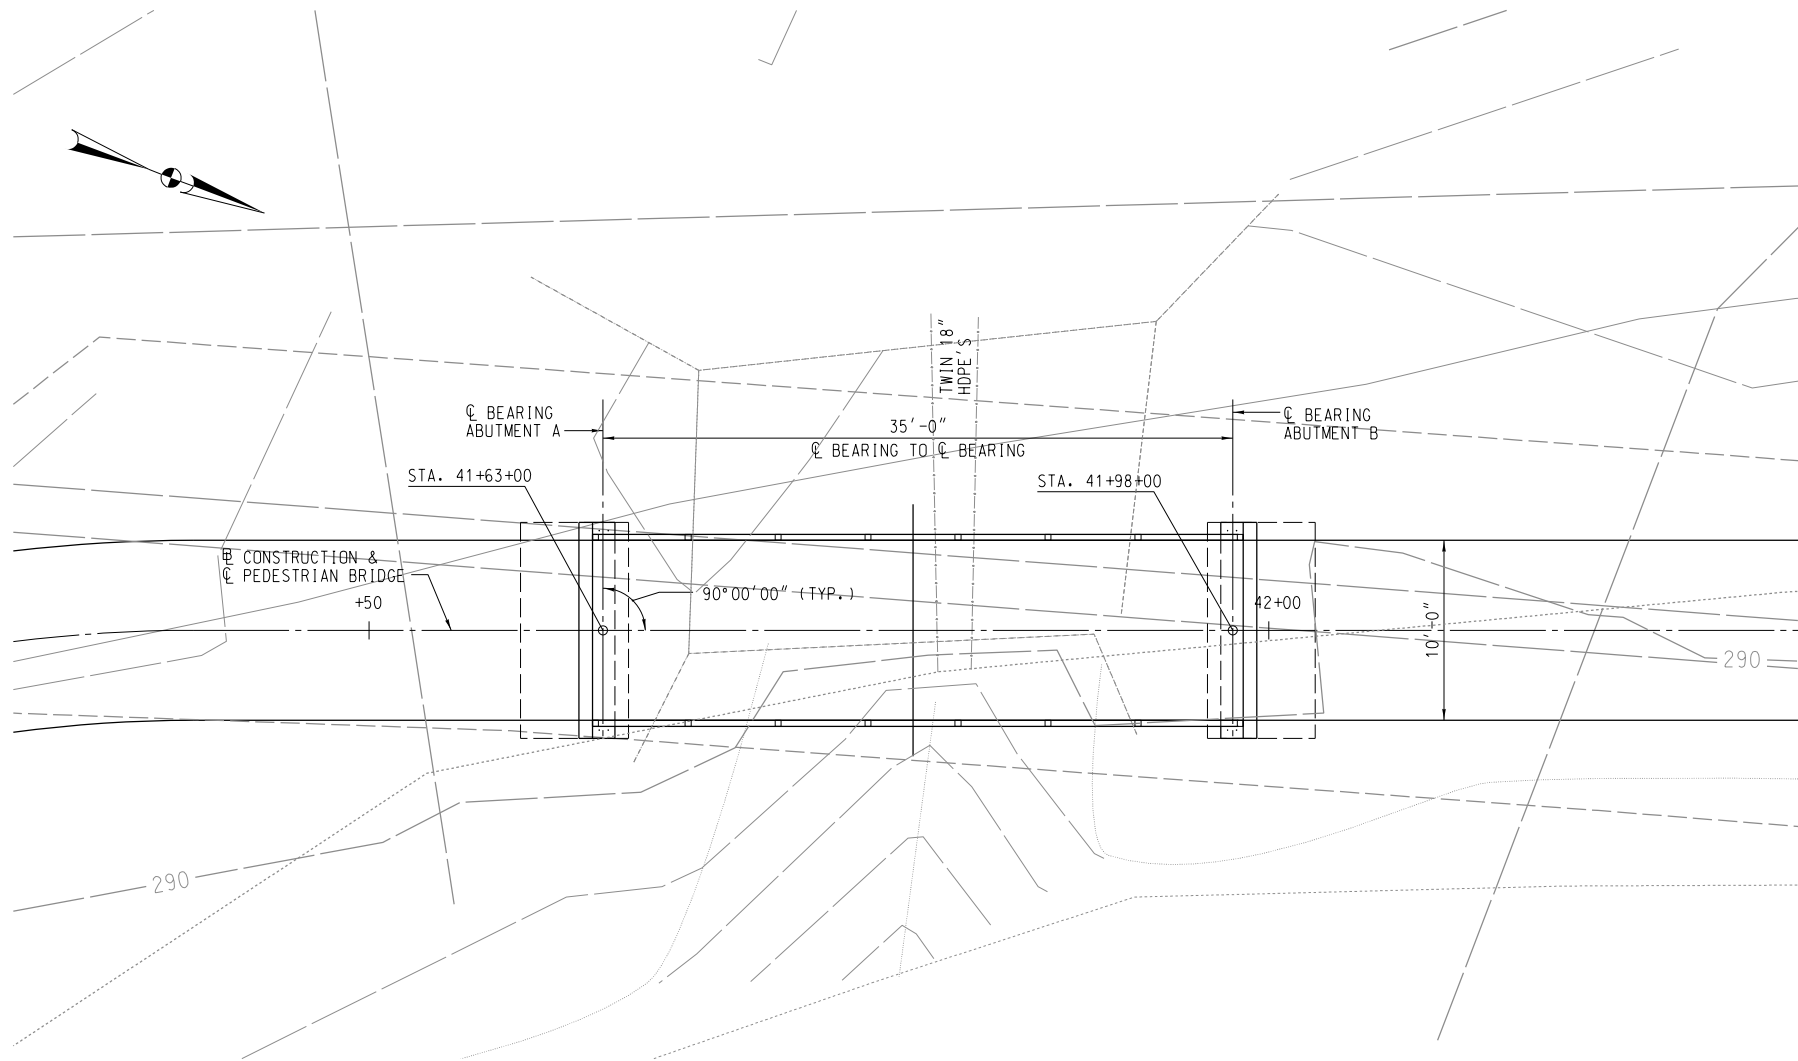
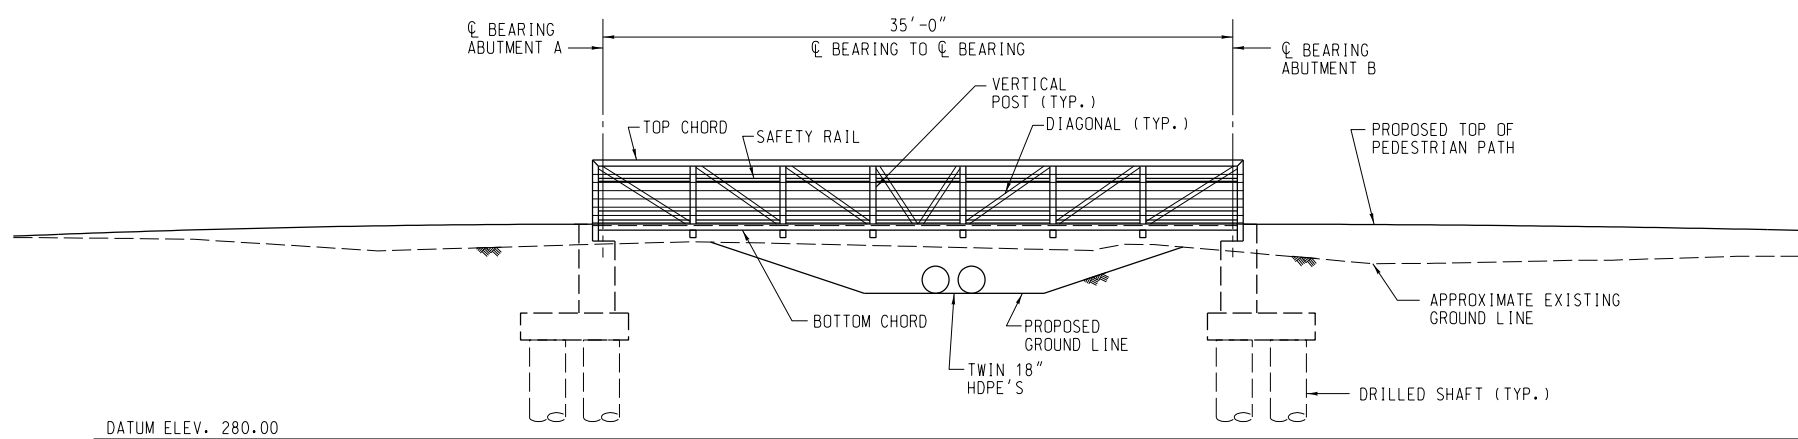
35' PEDESTRIAN BRIDGE  
GENERAL PLAN AND ELEVATION

PLAN  
SCALE: 3/16" = 1'-0"

ELEVATION  
SCALE: 3/16" = 1'-0"

The project includes two stream crossings over tributaries of the Little Patuxent River. One location is at Sta. 41+80 and the other at Sta. 67+00. Both crossings are anticipated to be a prefabricated steel pedestrian bridges. The span lengths for the two bridges are 35 feet and 50 feet. The design of both bridges will accommodate vehicular (H-5, 10,000 pounds) live loading to provide access for maintenance vehicles and emergency services. The bridges will be supported by cast-in-place reinforced concrete abutments which may be founded on reinforced concrete drilled shafts.
